Technical Preservation Services
Preservation Assistance Division
National Park Service
U.S. Department of the Interior
Washington, D.C.

Interpreting the Secretary of the Interior's Standards for Rehabilitation

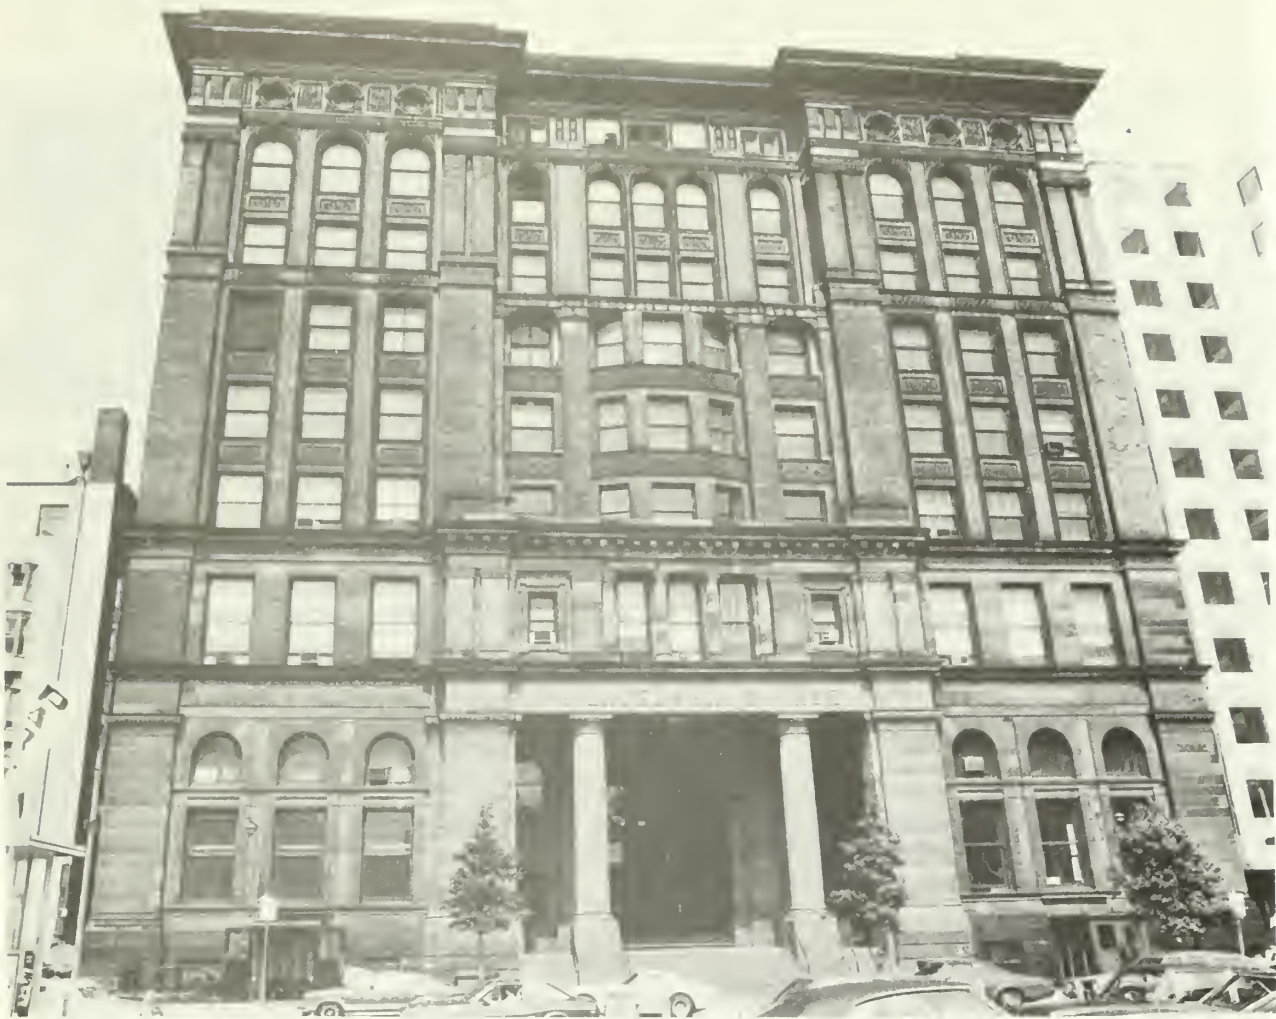
1. East elevation showing wooden vestibules flanking main entrance, added c. 1920.

Application: A nine-story, late Victorian brick and brownstone commercial building located in a historic district within a large northeastern city was being rehabilitated for use as a multi-purpose business and shopping complex (see illus. 1). When the proposal for extensive interior and exterior work was forwarded by the State Historic Preservation Officer to NPS for review, NPS concurred with the State's general assessment of nonconformance with the Secretary's Standards and denied certification, listing violations of Standards 2, 5, 6, and 9. Exterior work cited for nonconformance included window alterations and the design for new glass canopies to cover areaways flanking a main entrance. Nonconforming interior work included demolition of an existing skylight; large cuts in the main floor; introduction of a mezzanine; and construction of two curved staircases linking the interior levels.

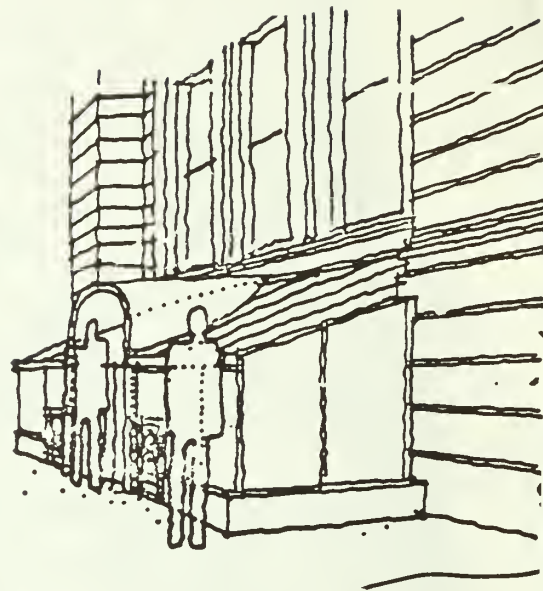
4. Revised canopy design met the NPS height condition but introduced potential pedestrian safety problems.

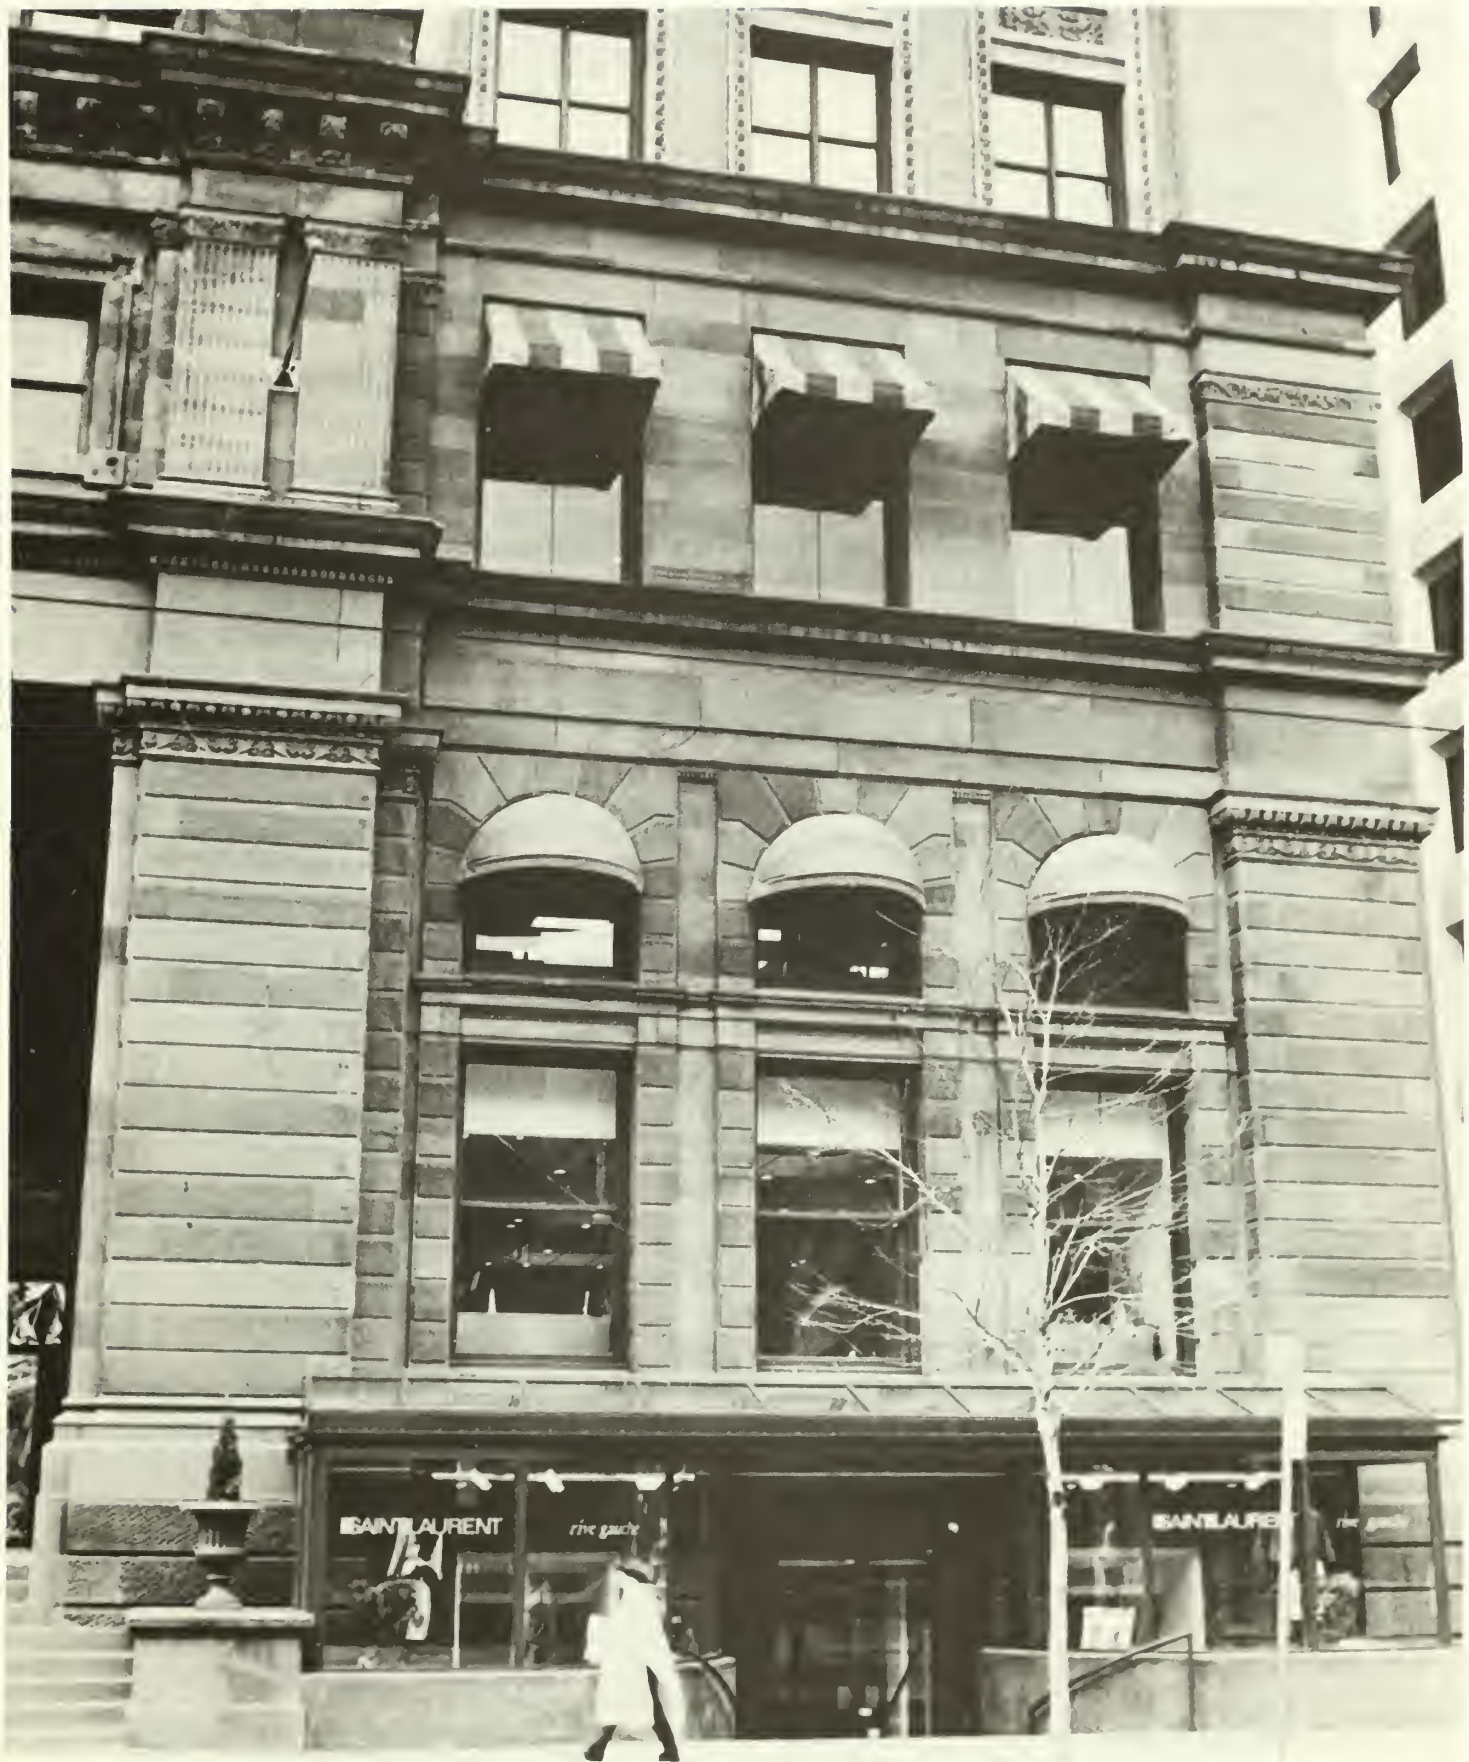
6. The Option A entrance canopy in place.

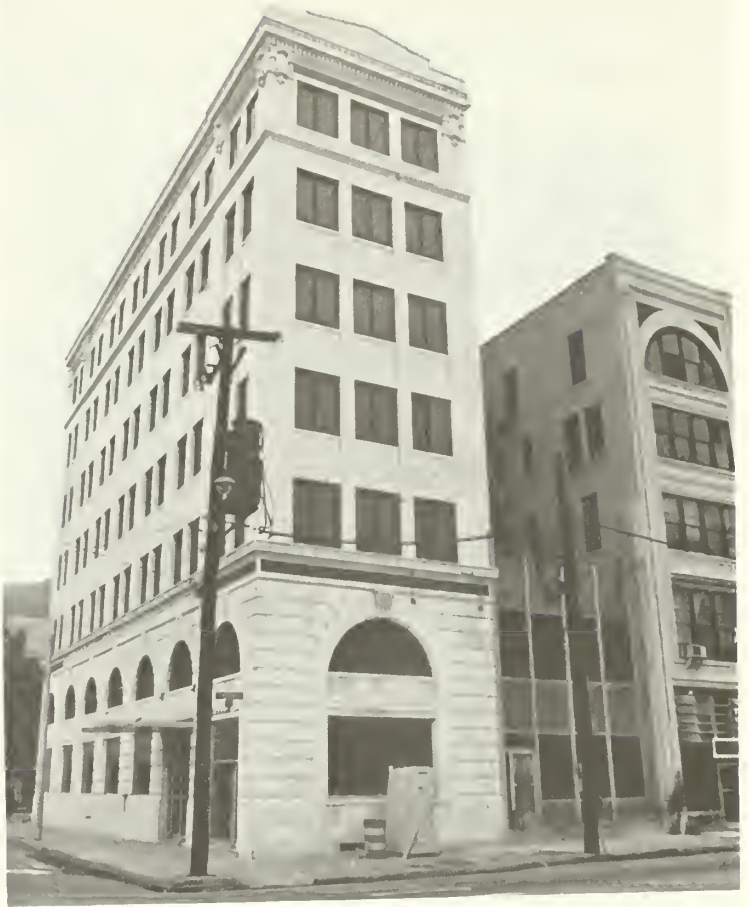
2. New windows with dark tinted glass and a vertical division on the upper floors were not in keeping with the character of the building.

In the course of rehabilitating the building for mixed commercial and residential use, the double-hung clear-glazed wooden windows were removed (and stored) and replaced with metal windows with a single vertical division created by a meeting rail. In addition, a dark tinted glass was used in place of the original clear glazing (see illus. 2 and 3). The change in the design and the use of dark tinted glass gave the new windows a strong contemporary look not in keeping with the historic character of the building. Upon submitting a certification application, the owner was advised that the window alterations did not meet numbers 2, 5, 6 and 9 of the Secretary's Standards.

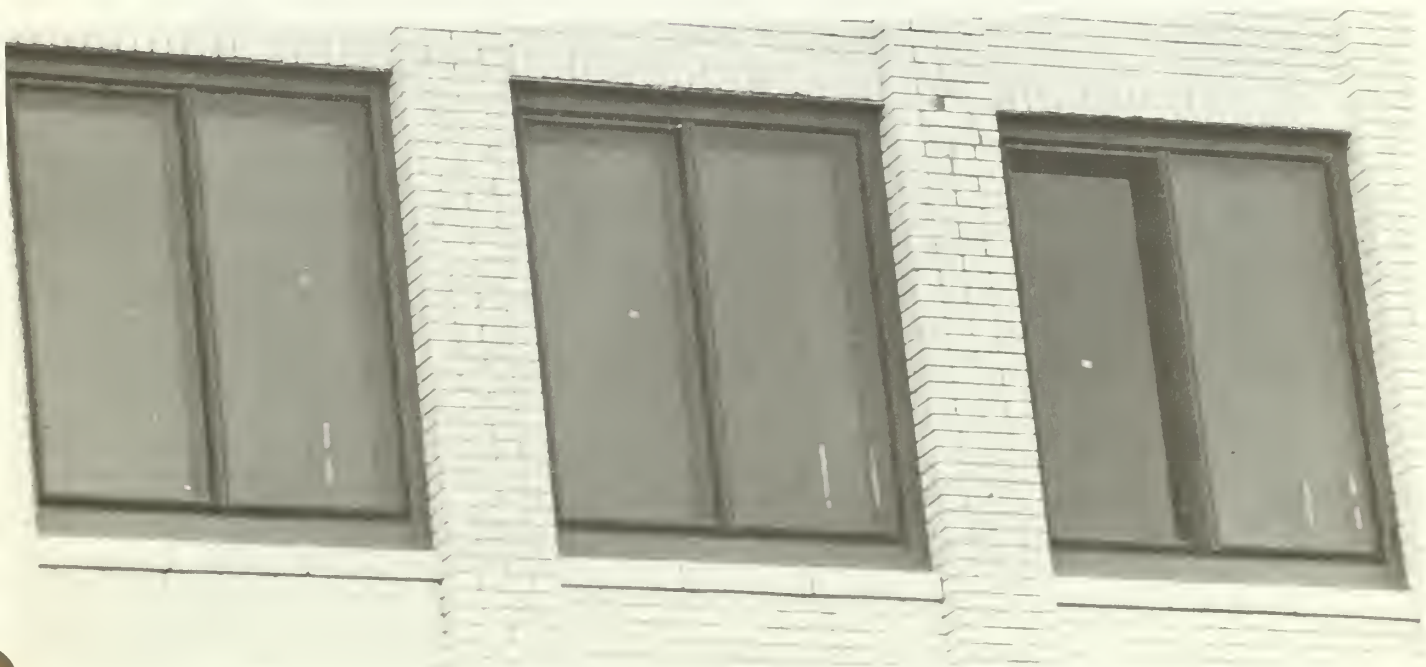
3. Close-up view shows the vertical division used in the new windows.

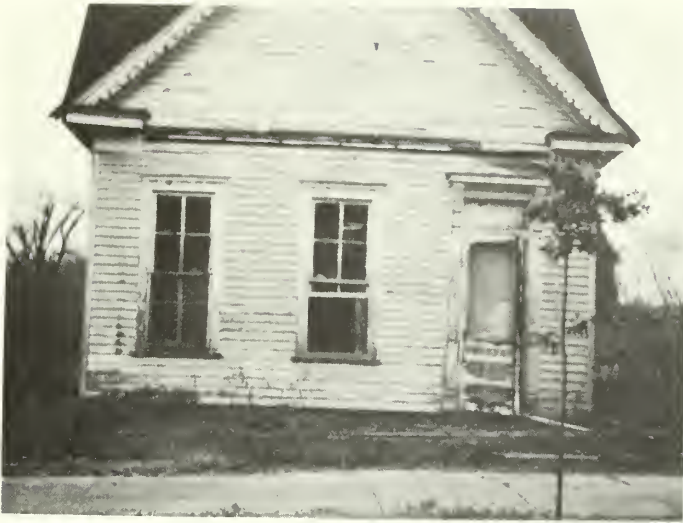
4. The 1880s cottage was in deteriorated condition prior to rehabilitation. Ghost marks of missing porch are evident. The original 2 over 2 windows had survived on the front and were to be repaired according to the plans submitted to NPS for prior review.

Plans for the rehabilitation of a small late nineteenth century cottage, located in a historic district in the South, were submitted prior to undertaking the work. After the determination was made by NPS that the proposed work met the Standards, the owner elected to revise the plans to include the removal of the two original first floor windows and subsequent replacement with floor-to-ceiling windows (see illus. 4 and 5). Upon completing the work and requesting final certification the owner was advised by NPS that the introduction of the new sash and exterior shutters which extend to the porch floor created a design feature that never existed in this particular structure and gave the building an inappropriate historic appearance. Moreover, NPS indicated to the owner that this particular type of window generally was found in buildings of an earlier period in that area.

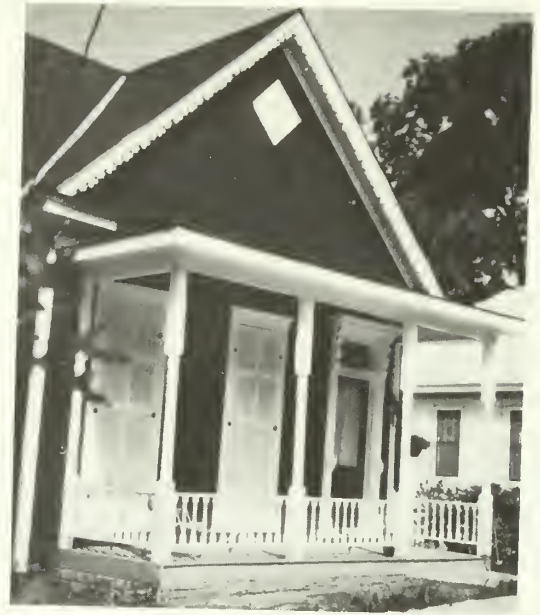
5. In the course of rehabilitation the owner elected to remove the original windows and install new ones in a historic design which extended to the first floor. Full-length blinds were also added.

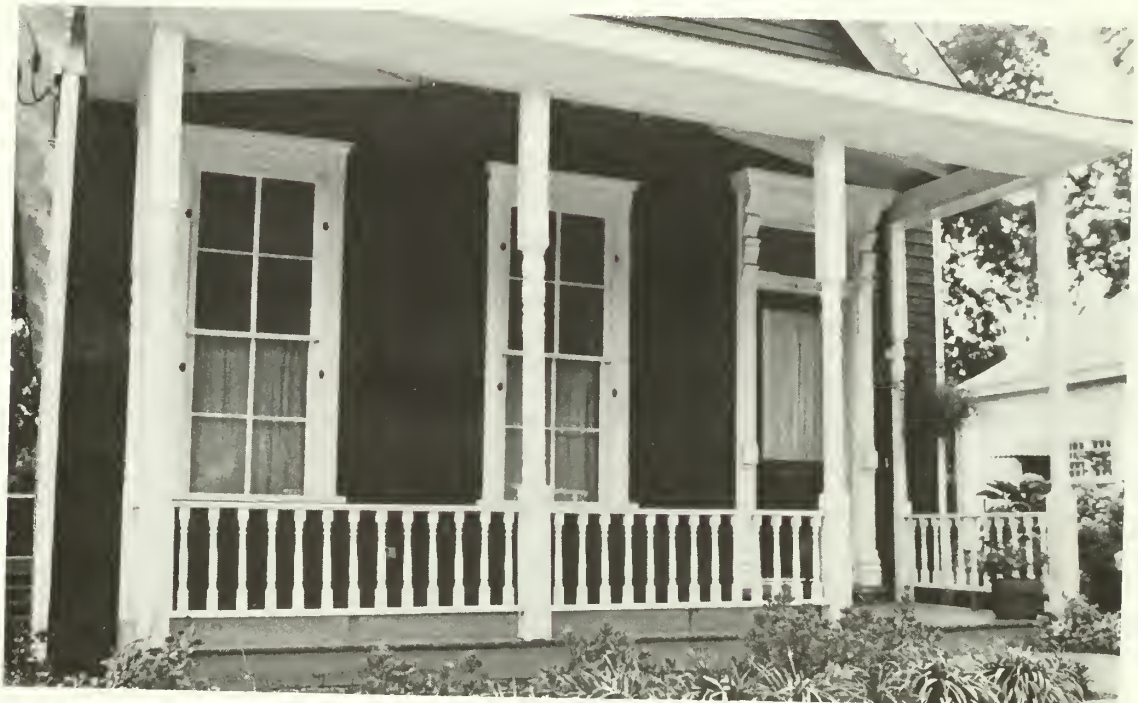
6. After the work was determined not to meet the Standards because of the window alterations, the owner proceeded to reinstall the original ones and thus obtained certification.

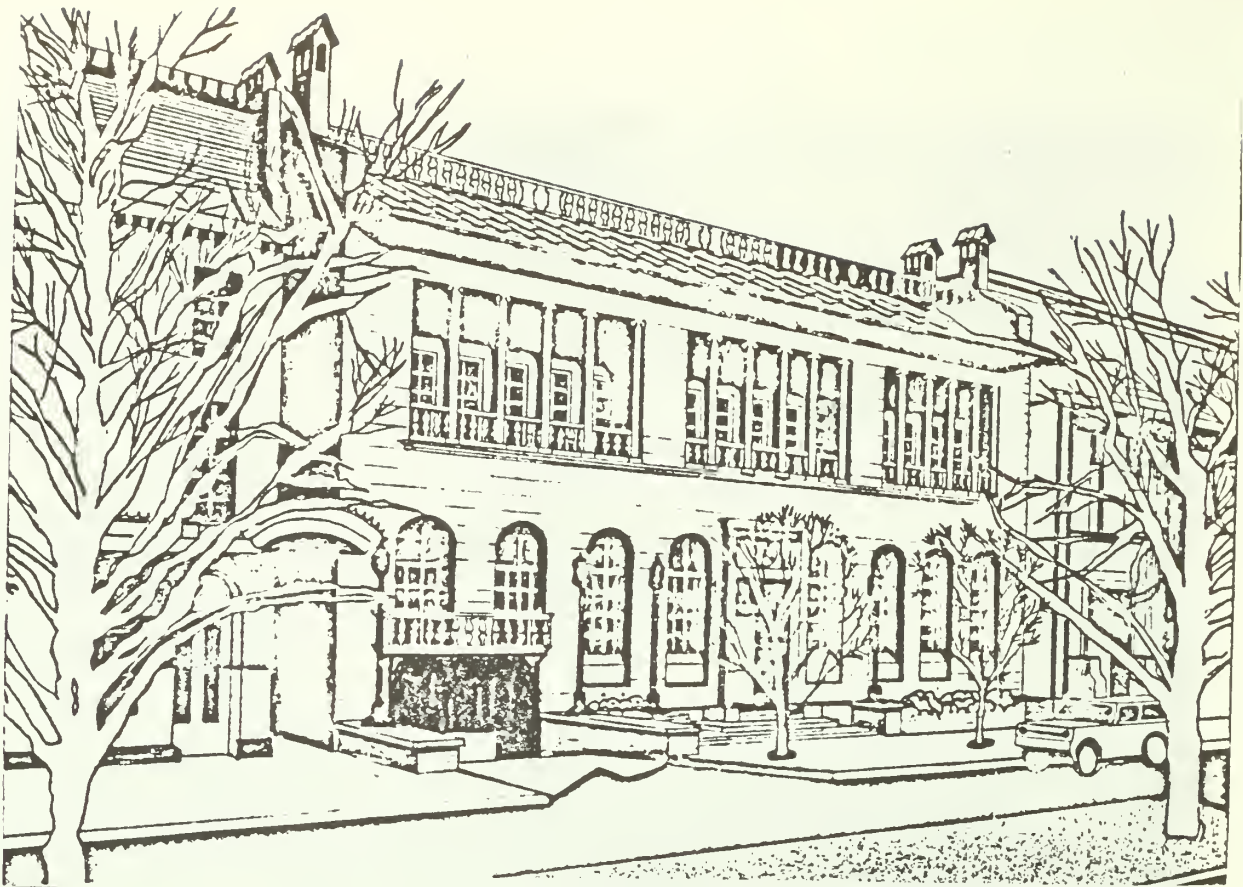
3. The original parking entrance proposed for the facade. The balustrade over the entrance was intended to serve as a visual "connector" to similar original features on the facade. The library slated for partial demolition is located behind the proposed entrance.

The introduction of the garage entrance on the principal facade alters the character of that well-detailed, Second Renaissance Revival-style facade. Not only does it result in the demolition and removal of historic material of significance, but it would also interrupt the rhythm and balance that is characteristic of this symmetrical facade (Standard 2). In addition, significant architectural features of the library--the bookcases, fireplace mantel, and decorative frieze--would be lost if the garage entrance is constructed as proposed (Standard 5). The Standards recommend a compatible use for a building that requires minimal alteration (Standard 1). Parking which requires a major opening on a principal facade cannot be considered a compatible use requiring minimal alterations. It is irreversible and destroys the form and integrity of that facade. The essential form and integrity of the structure should be unimpaired should alterations be removed in the future (Standard 10). While this office recognizes the arguments presented on the parking issue, the rehabilitation still must be consistent with the historic character of the structure and the Standards.

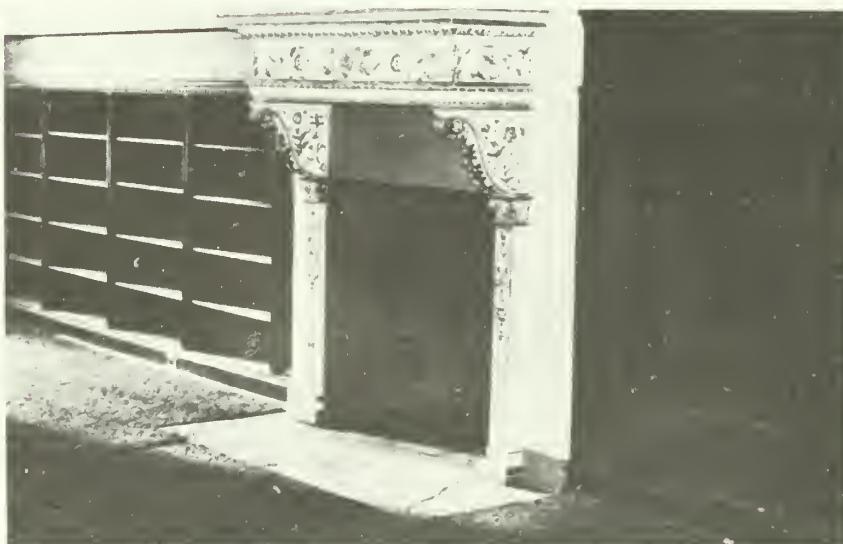
4. The parking entrance through the library would have necessitated removal of the fireplace and bookshelves.

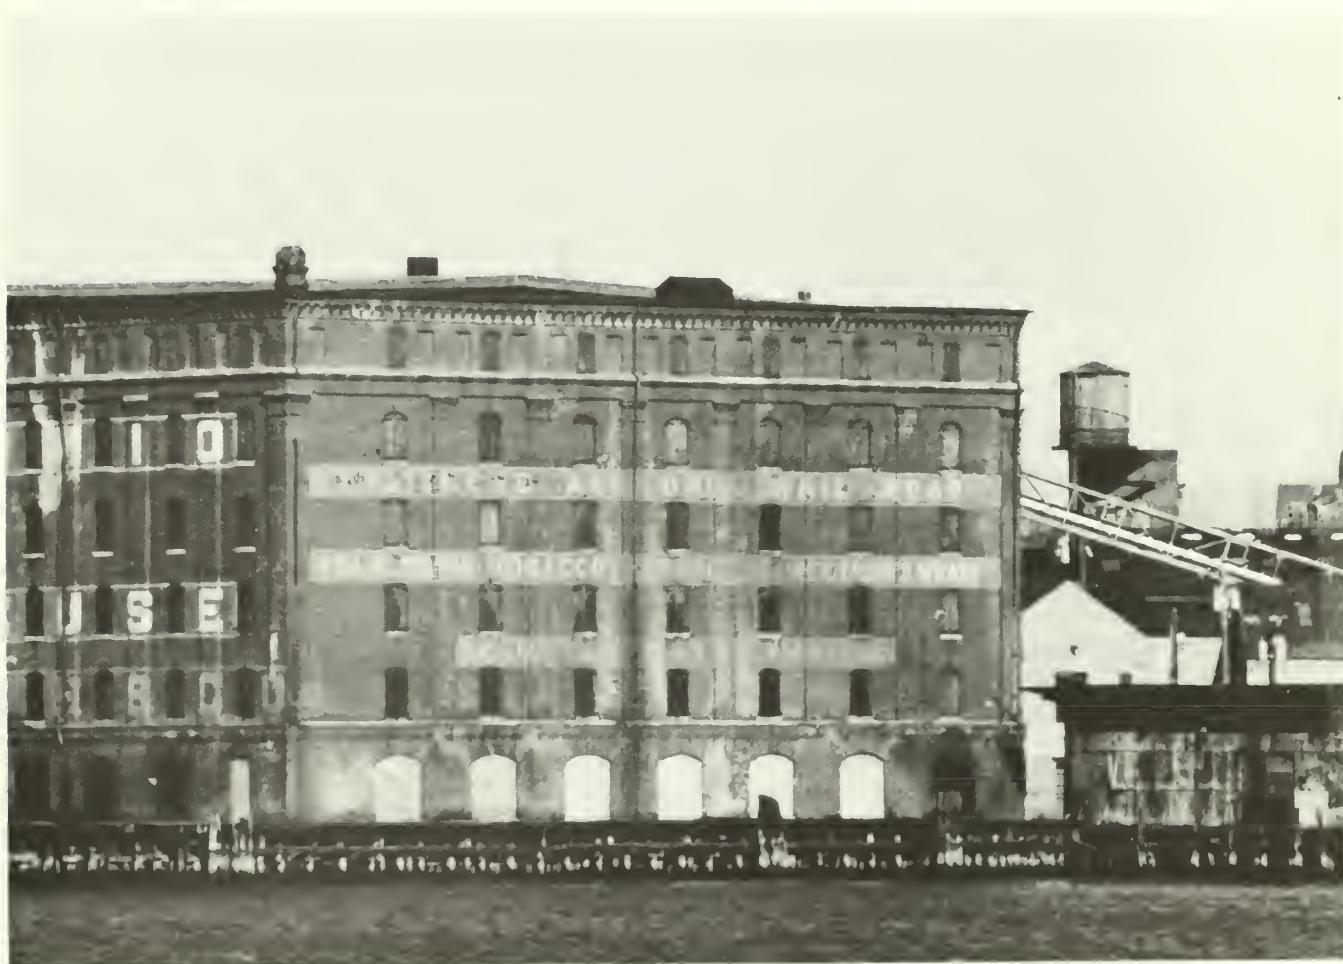
1. The existing south elevation of the 1890s warehouse building with its alternating bands of pilasters and window openings. The size of the openings decreases as the building progresses from the base to the top floor. The brickwork was quite sophisticated for a warehouse structure.

Application: A circa 1890s six-story brick tobacco warehouse located in a historic waterfront district was purchased for conversion to 204 apartments and first floor commercial space. The building was in good condition, although it had been vacant for many years. The city hoped that the conversion of this warehouse to apartments would be the first step in revitalizing this portion of the waterfront area, particularly since the building was the largest in the primarily residential district and formed the corner of the historic district boundary. A market study was commissioned by the owners to determine what changes would be necessary to make the building marketable. The study recommended that at least 85% of the residential units have a waterfront view, that a portion of the interior of the building be removed to provide necessary light and ventilation to meet code requirements, that some of the windows be widened as well to meet code requirements for light and ventilation, that all units have an exterior balcony and that a seventh floor be added to the structure to increase the number of rentable

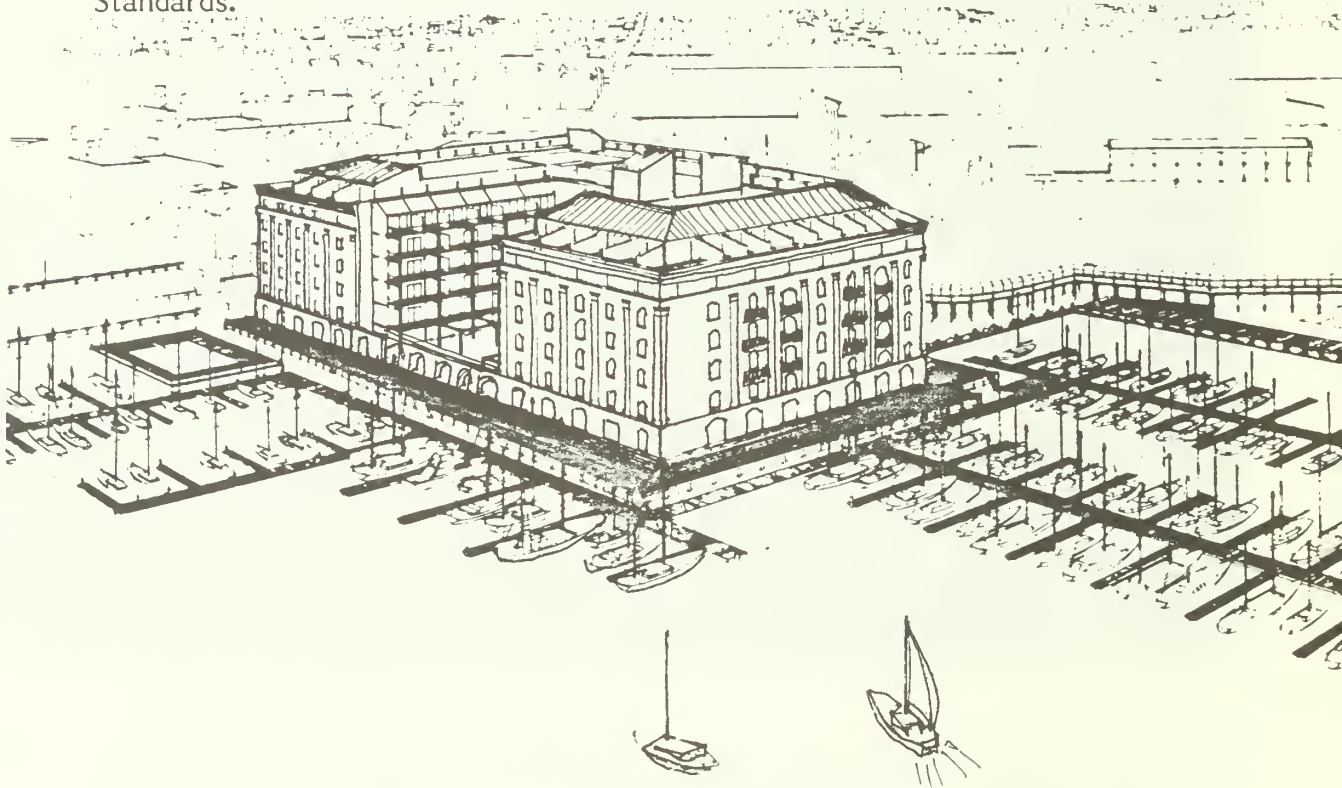
3. Perspective view of the proposed changes shows the large courtyard and the removal of seven bays of the waterfront facade in order to provide a water view for 85% of the apartment units. The hearing officer determined that the loss of significant original historic material and the drastic change in character created with the new "U" shaped plan did not meet the Standards. The projecting balconies and widened windows were also cited as not meeting the Standards. The setback rooftop addition, however, was not a concern as it would not have been visible from the street level of the historic district.

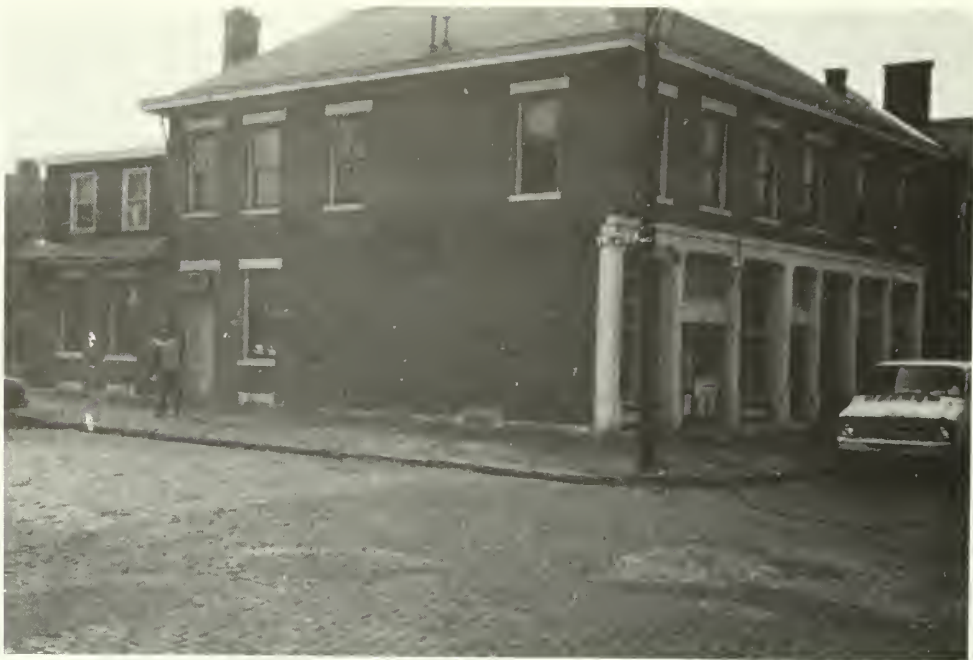
2a. and 2b. Building as it looked after ca. 1900 enlargement. Two identical storefronts (double doors flanked by window bays) were separated by a bay containing a single door.

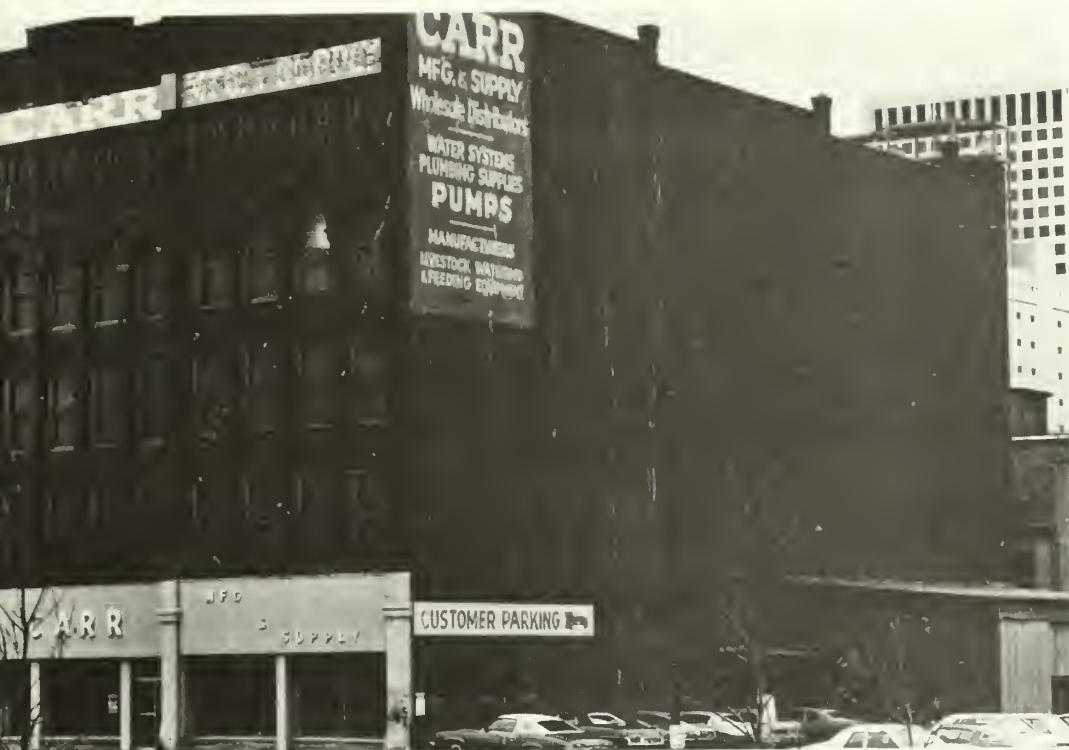
1. North and west facades of warehouse.
The 1960's storefronts are non-significant.

In planning for the rehabilitation of this warehouse, the owner determined that the only economically viable use was as luxury office space and that increasing the attractiveness of the space would require introducing windows into the blank west wall. Although the east wall did have some existing windows, the central load-bearing wall precluded "borrowing" natural light from the east across the width of the building. Additionally, the owner discovered that severe water damage had left the northwest corner of the warehouse structurally unsound and that part of the west wall would have to be rebuilt from the ground up.

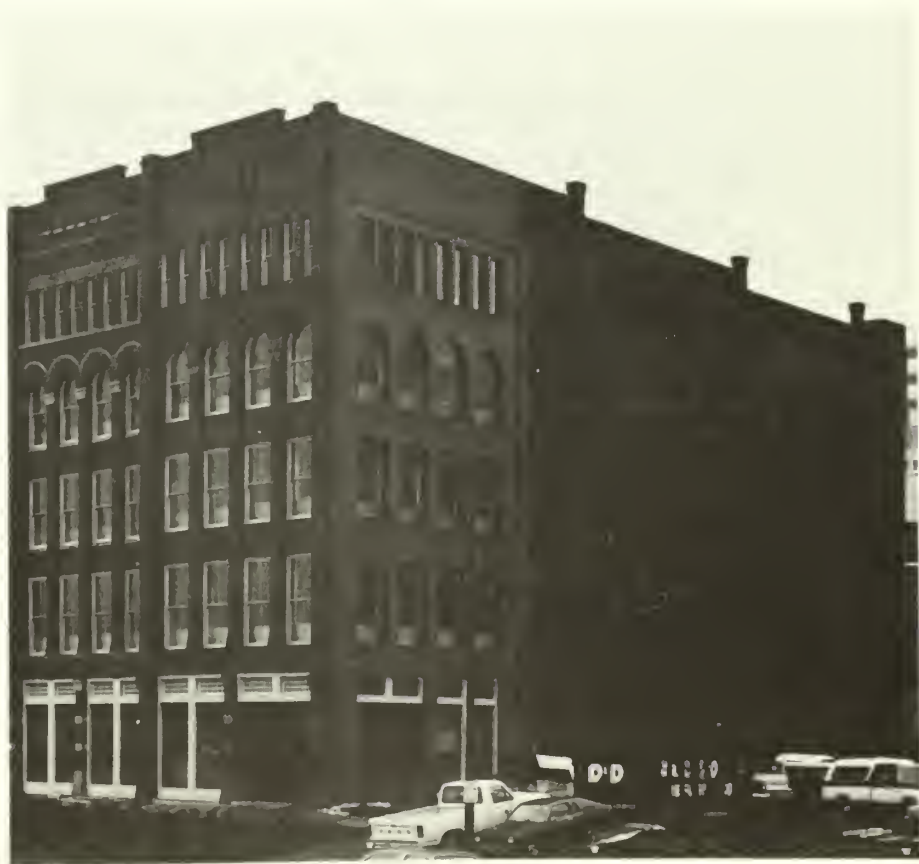
2. New windows and entrance on west facade. Certification was conditional upon owner adding a wooden column in center of westernmost storefront.

The rehabilitation, developed in close cooperation with the State, incorporates the new window openings into the rebuilt section of the west wall. The new windows are similar in size, shape, and rhythm to the windows on the primary north wall but the brickwork, sash, and glazing are clearly contemporary. The new brickwork is a slightly different color from the original and flush around the new windows rather than projecting; the sash is aluminum and a different color from the original, and the glazing is single-light. In rehabilitating the north facade, the owner carefully repaired the existing 2-over-2 wooden double-hung sash (see illus. 2).

The non-significant 1960's storefronts were removed and replacement storefronts were constructed, although the new use of the building might not include retail on the first floor. The replacement storefronts incorporate new matching brick and stone piers and new wooden windows and multi-light transoms. The newly constructed west wall also incorporates two "storefront bays" but uses a less decorative brick pier and plain transoms in order to continue the differentiation between the historic north facade and the contemporary section of the west wall. The entrance was moved from its 1960's location in the center of the north facade to the northwest corner of the building. Access is through open storefront bays from both the north and west which create a recessed entrance at the corner of the building (see illus. 2).

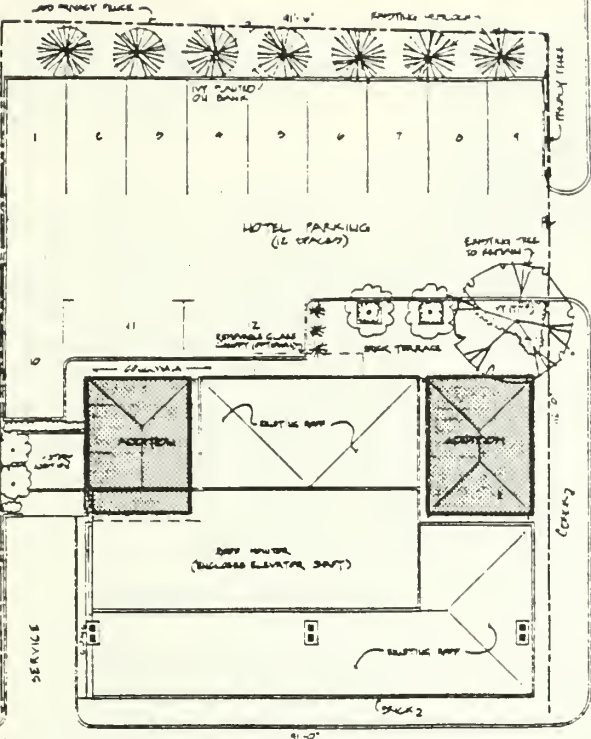
Illustration #1. Site Plan

The proposed two rear additions would change the plan from a "T" shape to a deep rectangle. In order to preserve the characteristic proportions of the Federal era, circa 1809, plan, it was determined that the new additions read as separate structures and not as a continuation of the historic structure.

In reviewing the initial application, the State office made note of several important aspects of the project that would require redesign. As a Federal era design, the pair of town houses was distinguished by narrow, one room deep "T" shaped plans. The state felt that the infilling of this plan should not give the appearance of earlier mid-Georgian plans that were heavier in mass and proportion. As such, the State recommended that the new additions read as separate structures connected to the historic resource, thereby preserving the original sense of the Federal plan. In addition, the new construction should be attached to the historic building with a minimum of damage to historic fabric so that if, in the future, the additions were to be removed, the basic form and integrity of the historic structure would remain.

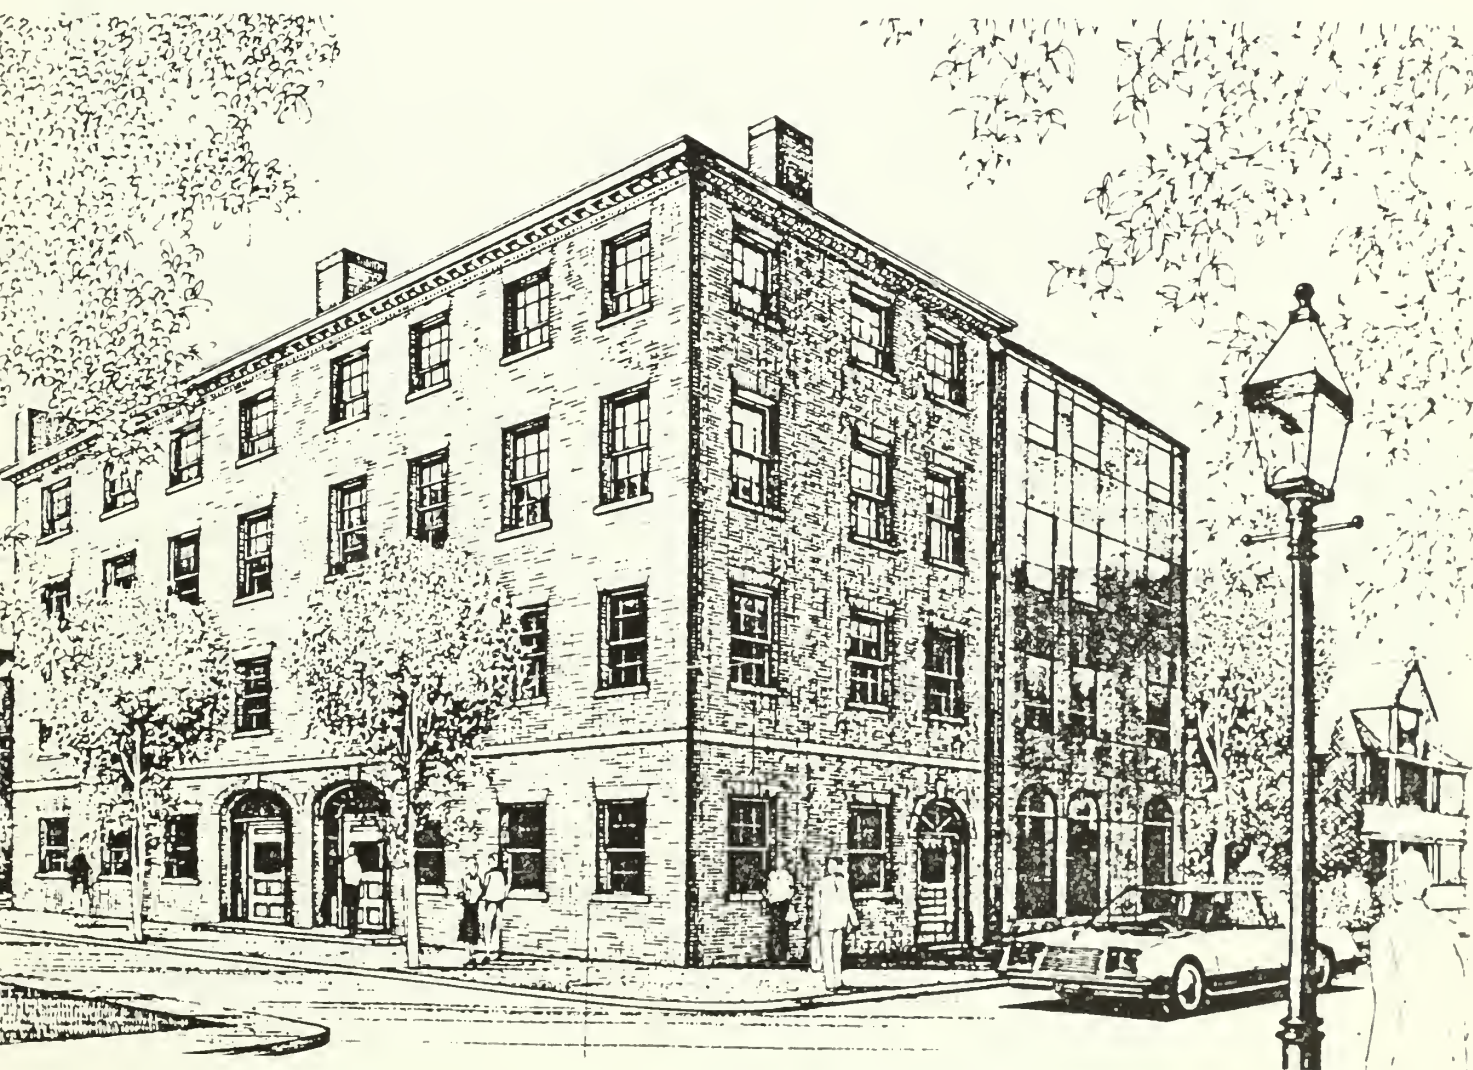
Illustration #2. PERSPECTIVE VIEW. The revised design treated the rear addition as a modern pavilion to clearly differentiate it from the historic structure.

The SHPO suggested that a contemporary design for the additions be considered, that the materials used provide a neutral backdrop for the historic resource, that the roofline of the additions be lowered so as not to damage the ornamental historic cornice, and that care be taken to minimize removal of historic fabric. In essence, the new rear additions should be treated as separate pavilions that would read as new construction in order to preserve the character-defining features of the historic resource. The owner was amenable to these suggestions and resubmitted his design (see illus. 2), which was then forwarded to the regional office with a recommendation for approval.

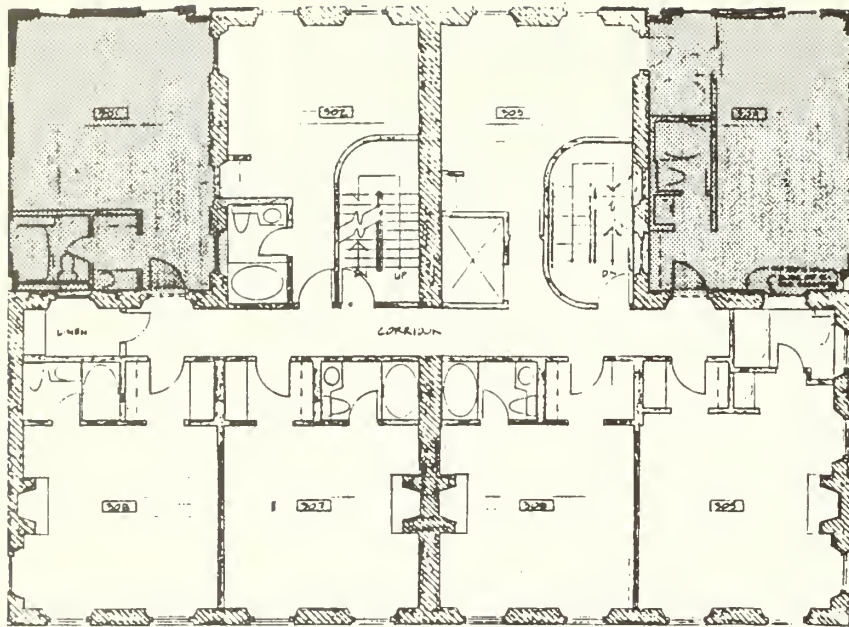
Illustration #3. TYPICAL FLOOR PLAN.
The proposed infill plan (shaded) would respect the historic materials by leaving the original rear walls exposed within the new addition. The existing window and door openings would be left in place, as much as possible. In addition, recessed panels would be used as a connector infill between the original building and the additions in order to clearly differentiate the new construction from the historic structure.

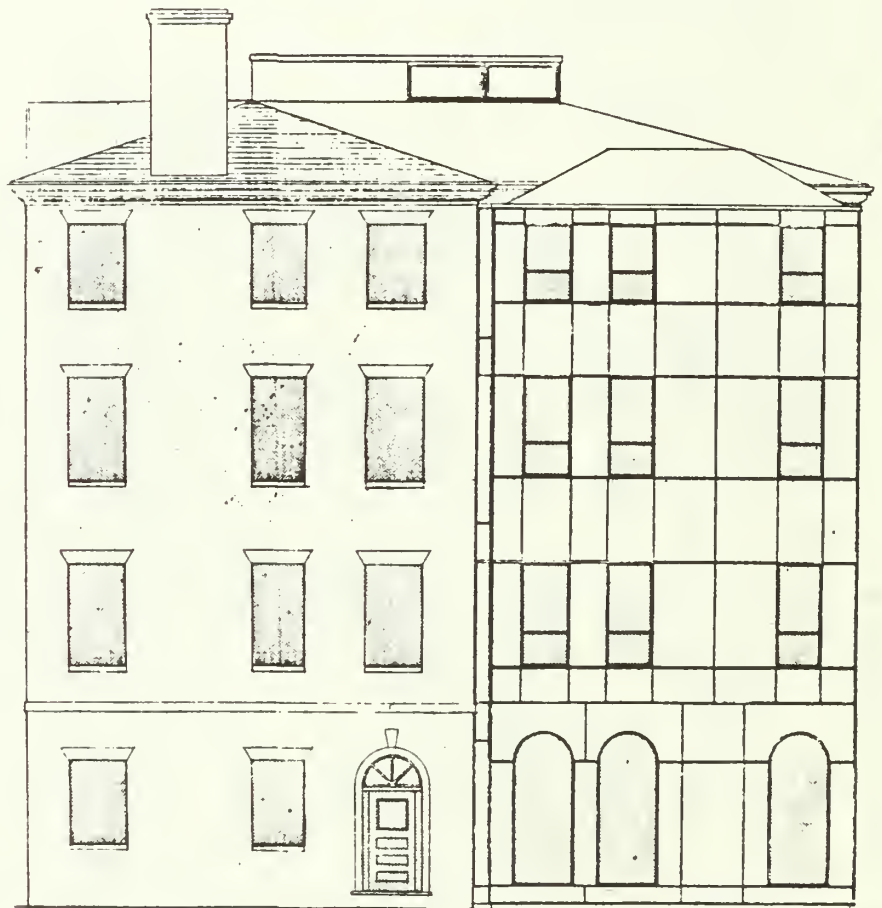
Illustration #4. ELEVATION

The new 4 story addition visible from the street would be compatible in scale and proportion with the historic structure. The pattern of window and door openings in the new addition would reflect the rhythm in the historic facade. The use of a modern panel system, as opposed to detailed brickwork, would clearly separate the new construction from the historic resource. The use of a separate hipped roof for the addition would retain the scale of the property and would eliminate damage to the historic roof and cornice.

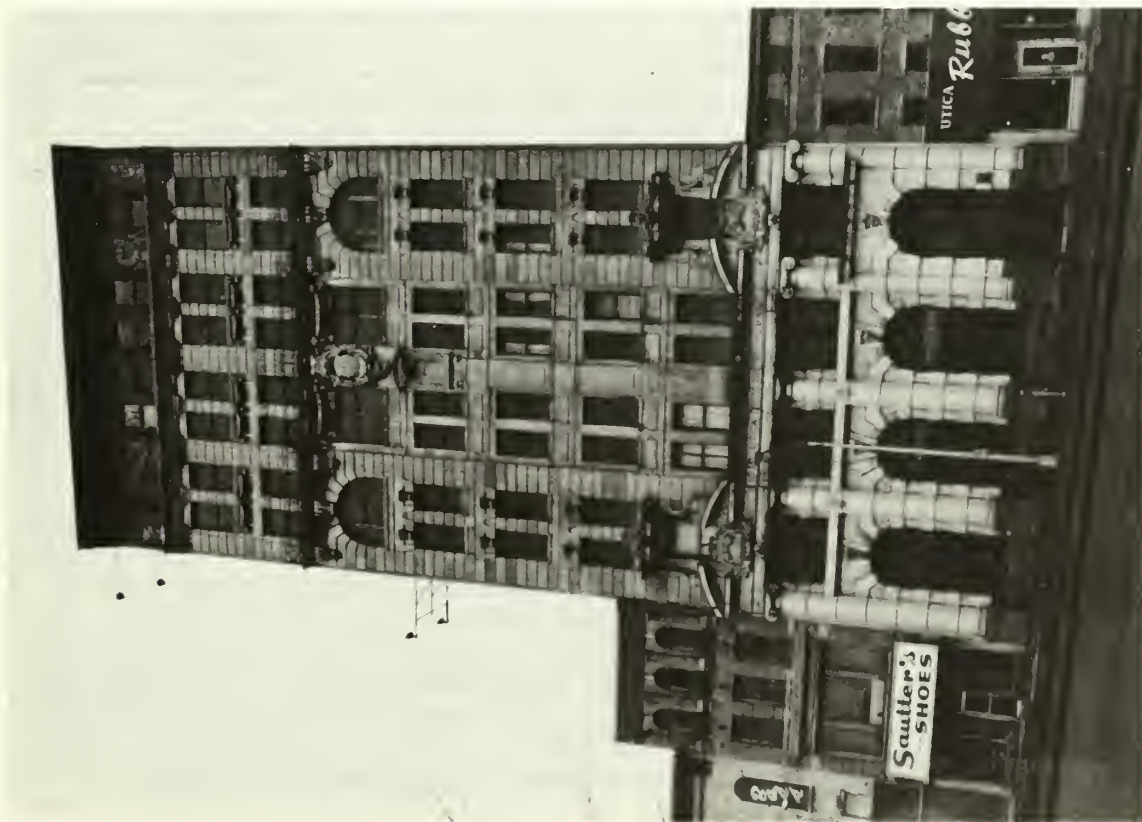
BEFORE

Original double hung window sash featured a mid-level, horizontal meeting rail.

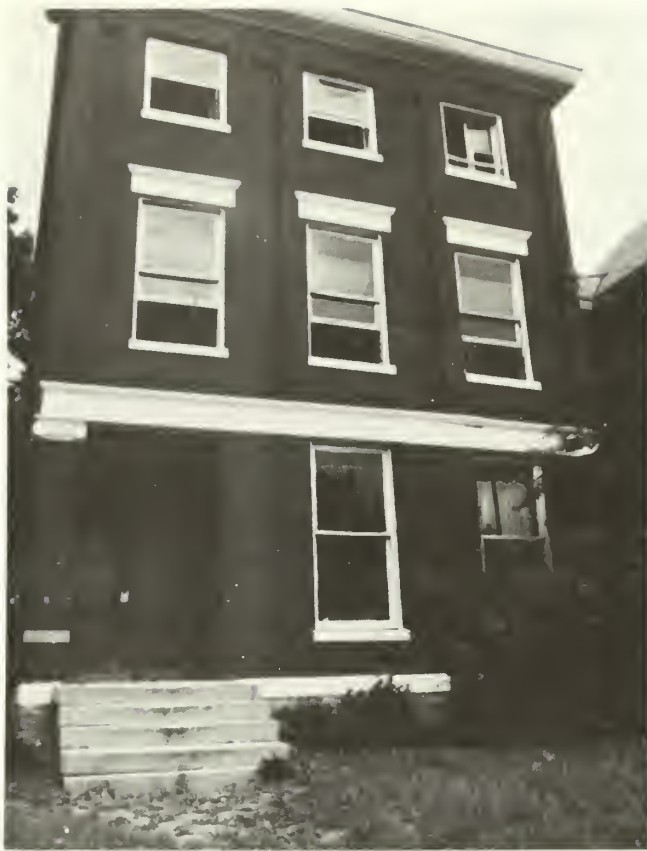
1. The townhouse, with its simple detailing, pictured before rehabilitation. The owner's proposal for exterior work was considered to be in conformance with the Secretary's Standards.

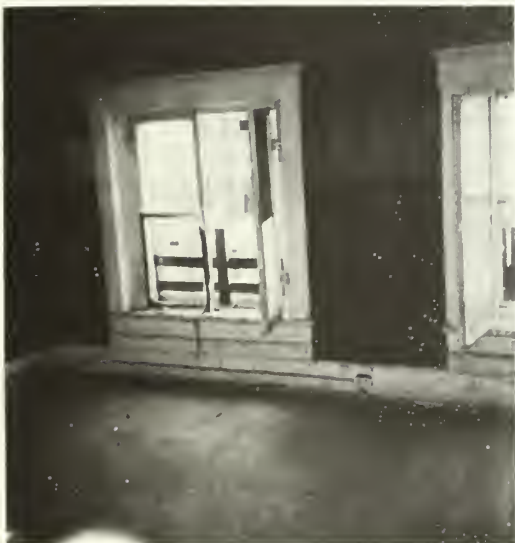
2. Modest interior detailing, such as window and baseboard trim, and diagonally placed mantels contribute to the historic character of the 1894 townhouse and thus should have been preserved to the greatest extent possible.

4. Interior work involved demolition of existing partitions as well as relocation of the living area to the historic entrance and stair hall space (see illus. 3). The rearrangement of rooms led to removal of corner mantels, baseboards, and door and window trim (see illus. 2). Because the character-defining interior spaces, features, and materials were not sufficiently preserved, the entire project failed to meet the Standards, despite qualifying exterior work.

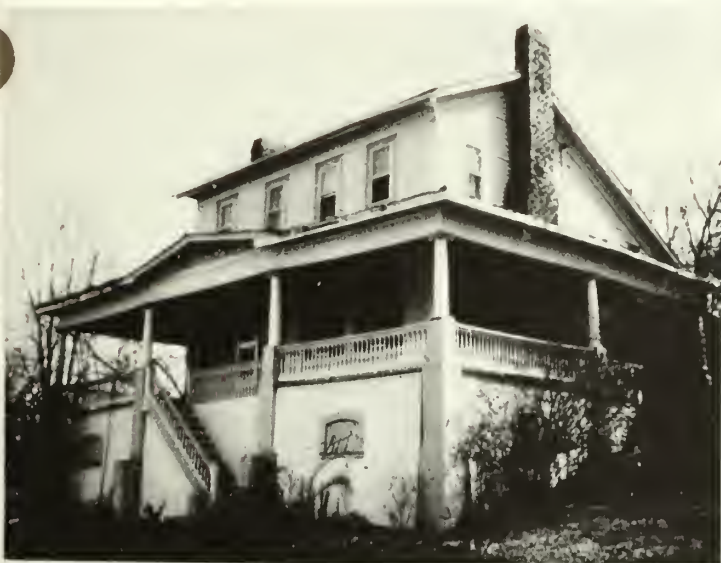
An 1830 structure with its large 1910 wrap-around porch characterized by columns resting on brick piers, highly decorative central pediment and turned balusters. The porch was in a deteriorated, but still fairable, condition prior to rehabilitation work.
